Gurage Sauer-Bét House Construction

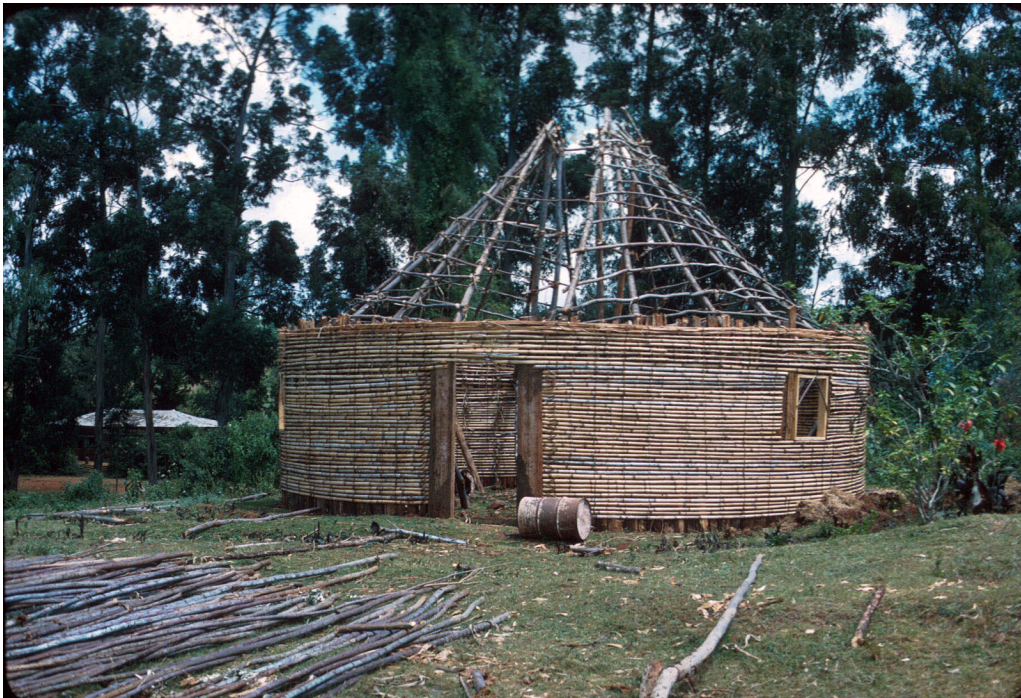
After tracing a circle for the wall, posts are placed in the circular trench, with eucalyptus siding strips woven together with local vines. Special posts mark the door with window framing cut out once the wall is complete. The next step is to installing scaffolding for the installation of the center post.

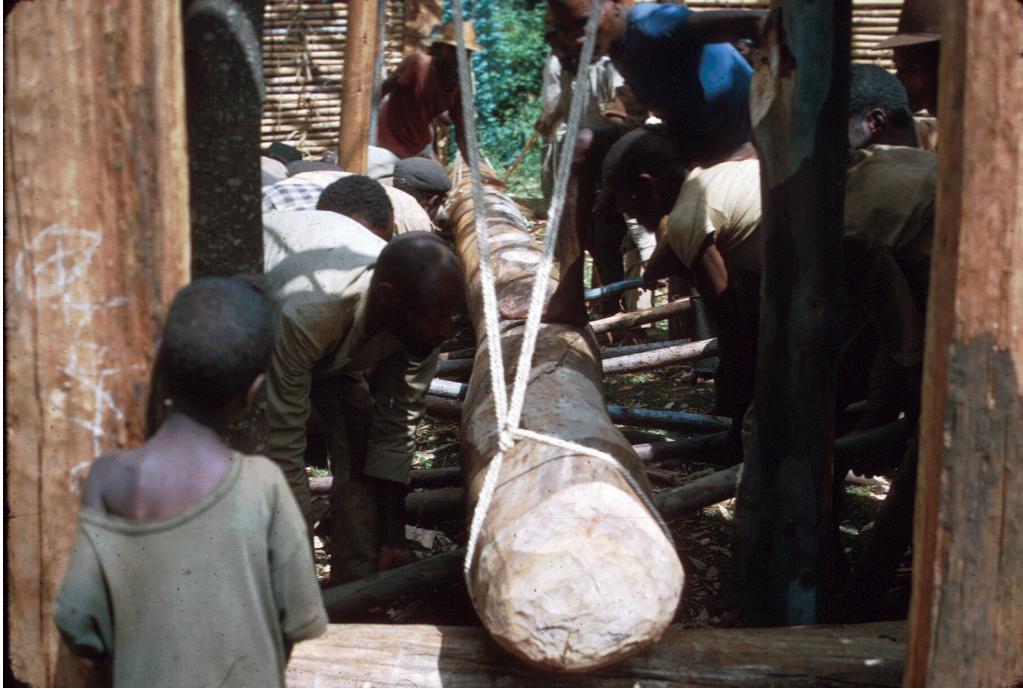
Hauling in the centerpost (wofincha) requires a team of workers.

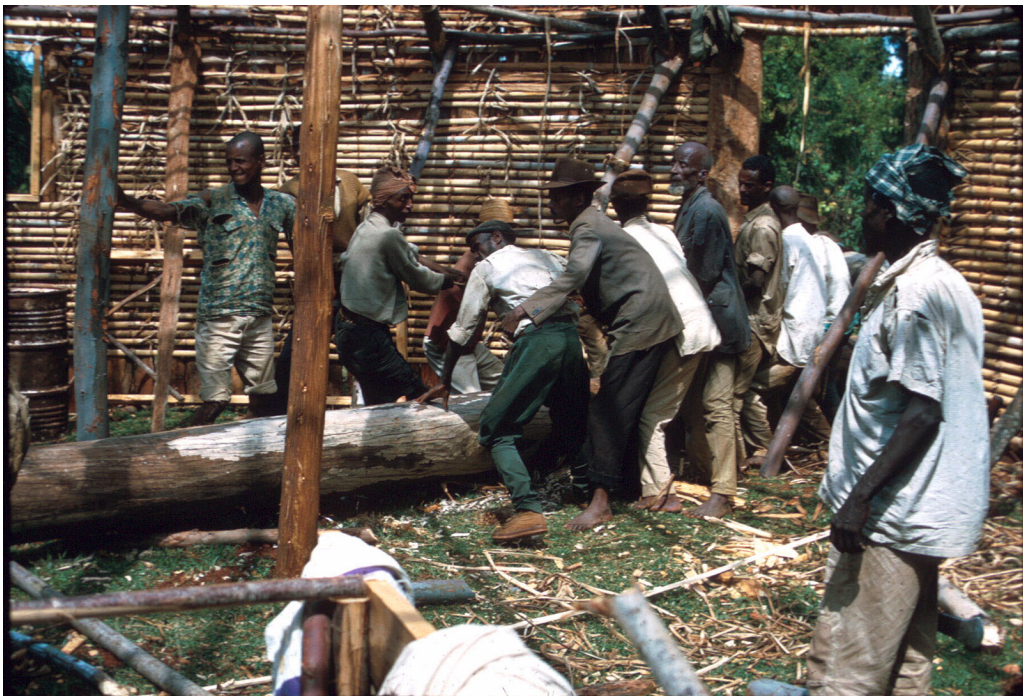
View of workers hauling the centerpost in place.

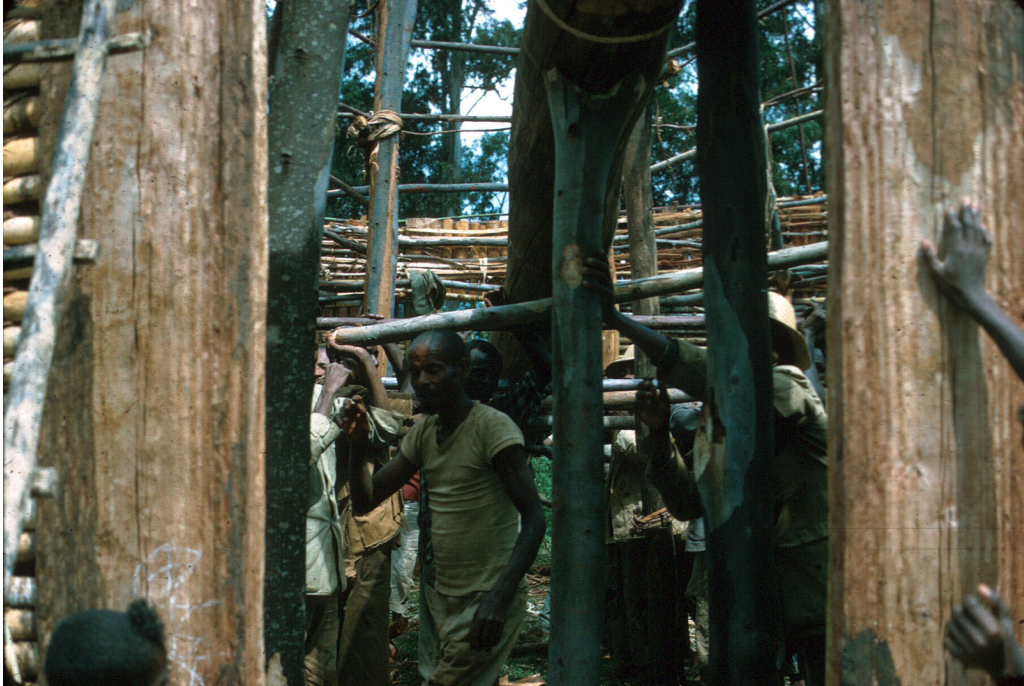
Raising the centerpost with wooden levers.

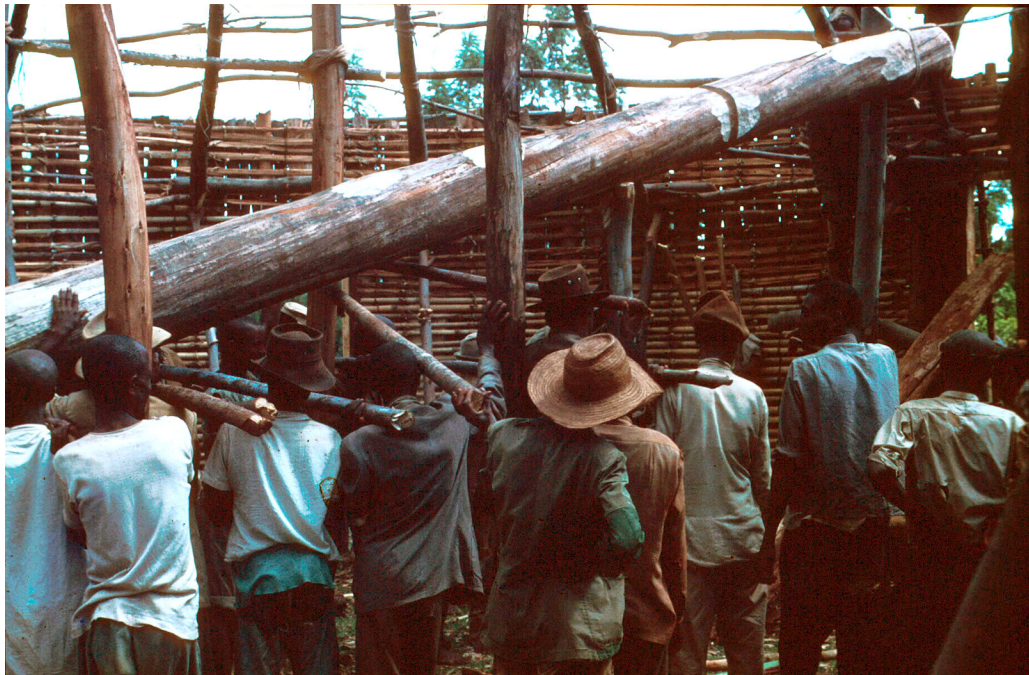
The centerpost is lifted above the circular wall.

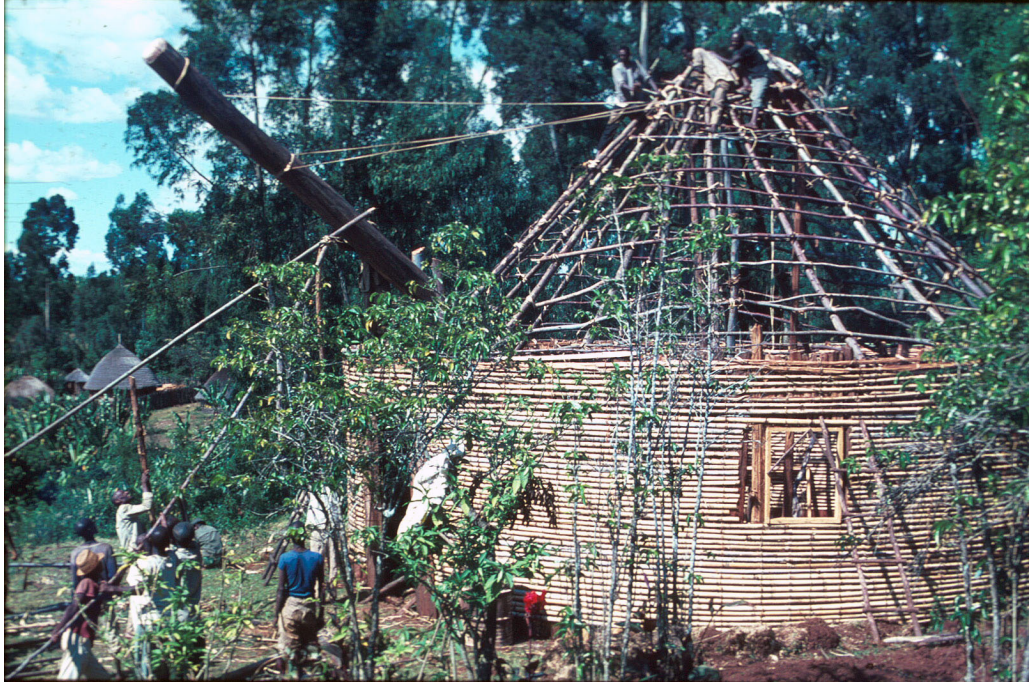
Workers atop the scaffolding pulling the centerpost to vertical position.

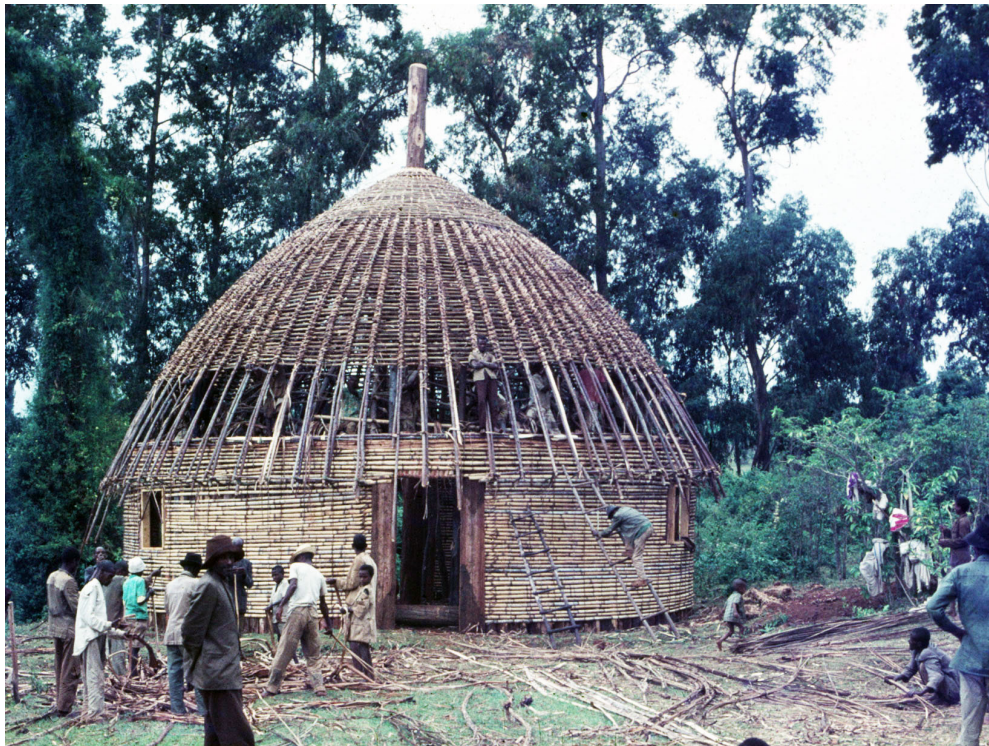
Once the centerpiece is lashed in place, the framing of the thatched roof is undertaken to give a bulbous shape to the roof.

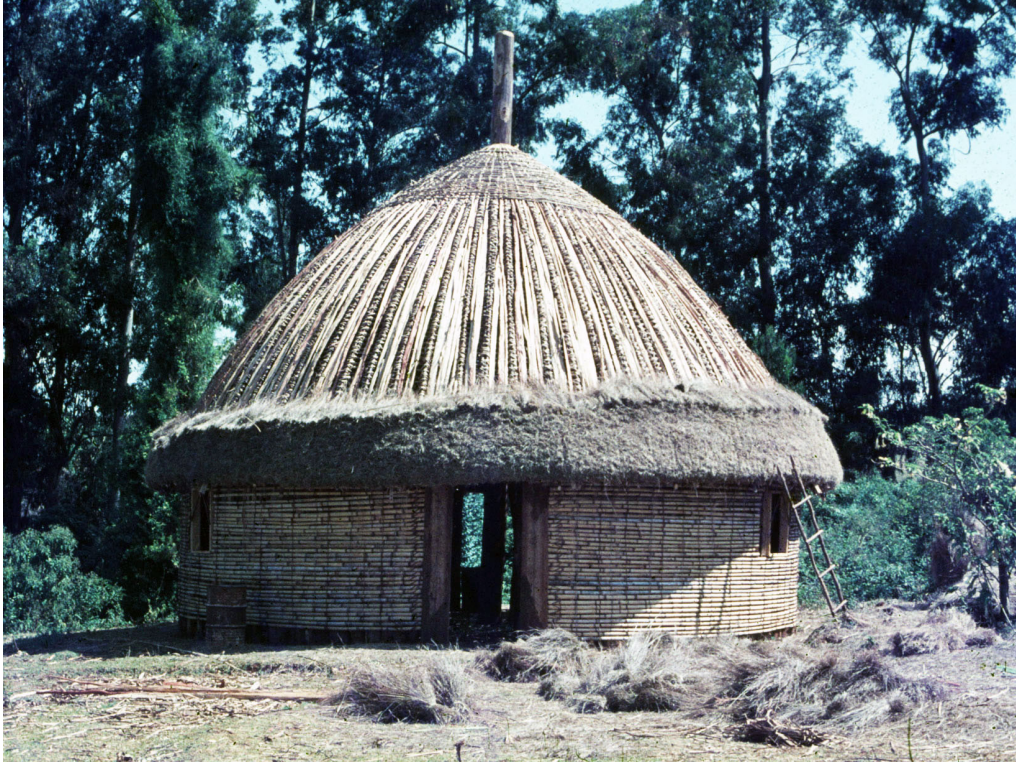
Thatching the roof is a spiral weaving process in which grouped thatch is woven to the roof framing.
